Hinson & Jung, LLC
21351 Village Green Circle
Germantown, MD 20876
Inspector Pete Jung
ph 301 351-1113 fax 301 542-0100

Home Inspection Report

1234 Any Street
Pleasantville, MD or VA 54321

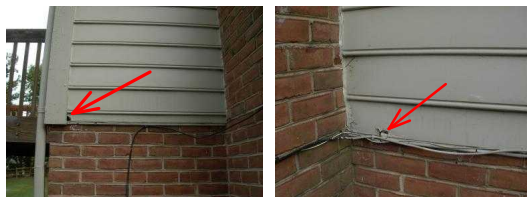
- 1. Type: Brick and wood Wood siding needs to be checked thoroughly to ensure that there is no wood rot. There are several areas near the brick chimney, left side of the house that need attention. Recommend a licensed contractor to make necessary repairs.

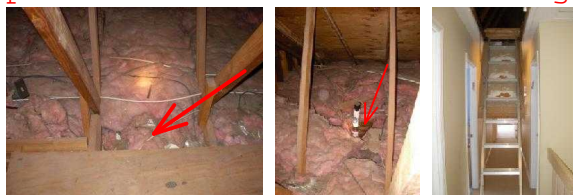
1. Method of Inspection: Entered attic
2. Roof Framing: 2x4 Truss
3. Sheathing: Plywood
4. Ventilation: Gable and soffit vents Evidence of a mold like substance on several of the 2X4's of the truss system. I do recommend that it be remediated. This is also an indication that there is not adequate ventilation in this attic. It is important that the attic fan is working when the attic temperature reaches 110F.
5. Insulation: Batts of fiberglass
6. Insulation Depth: 0" to 6" Recommend additional insulation be installed; total of 12" needed. There should be as much insulation over the top of the attic stairs as found elsewhere in the attic. Sometimes a light wood frame is built with hinges on one side. Insulation is fastened to the top and it is pushed to the side when entering the attic.

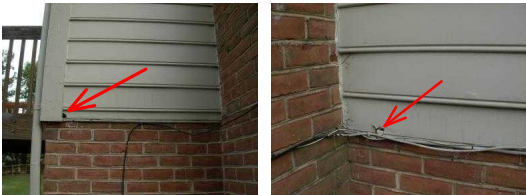
3. **Whole house Exterior Surface Type:** Brick and wood **Wood siding needs to be checked thoroughly to ensure that there is no wood rot. There are several areas near the brick chimney, left side of the house that need attention. Recommend a licensed contractor to make necessary repairs.**

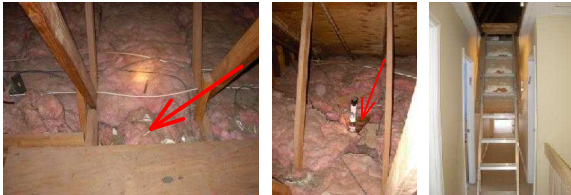
12. Main Attic Insulation Depth: 0" to 6" Recommend additional insulation be installed; total of 12" needed.

There should be as much insulation over the top of the attic stairs as found elsewhere in the attic. Sometimes a light wood frame is built with hinges on one side. Insulation is fastened to the top and it is pushed to the side when entering the attic.
